TEGRA LINUX DRIVER PACKAGE R28.1

RN_05071-R28 | July 20, 2017
Advance Information | Subject to Change

Release Notes

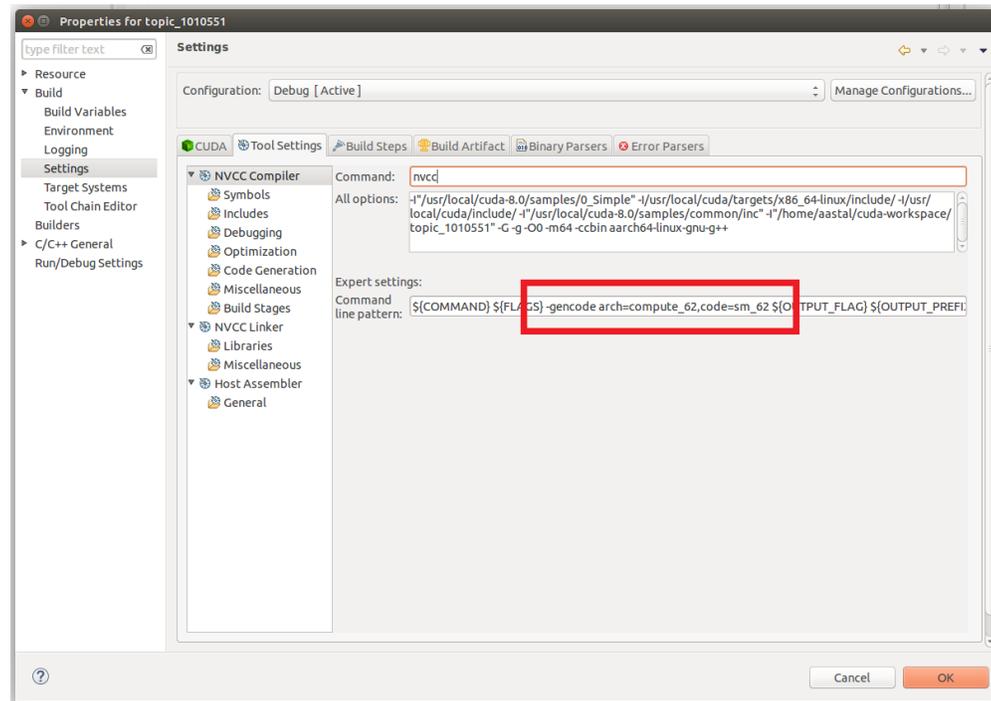
200322307

NVIDIA NSight does not provide an option to compile for SM 6.2 GPU architecture implemented on Jetson TX2.

To workaround:

1. Use the Expert setting to add the following option to both NVCC compiler and Linker.

```
-gencode arch=compute_62,code=sm_62
```

2. In the NVCC Compiler, navigate to Properties -> Settings -> Tool Settings -> NVCC Compiler -> Expert Setting:

3. In the NVCC Linker, navigate to Properties -> Settings -> Tool Settings -> NVCC Linker -> Expert Setting:

Consult the image for details:
