# **NVIDIA DGX H100 Firmware Update Guide**

**NVIDIA Corporation**

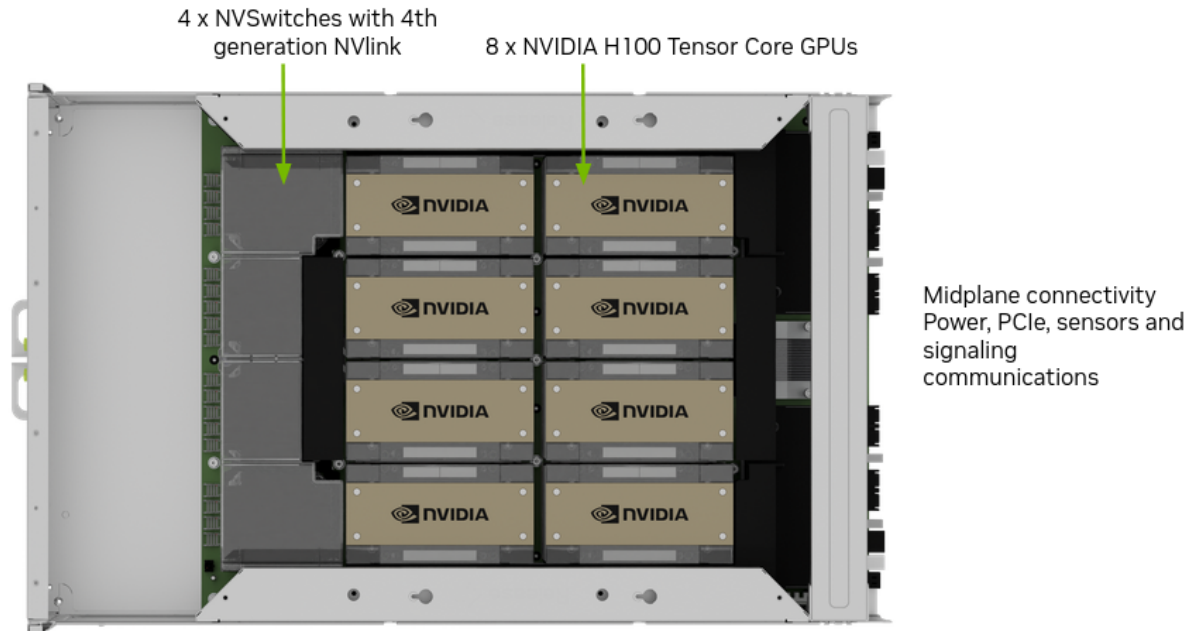
- ▶ The GPU tray has components, such as the GPUs, NVSwitches, HMC as shown in the following figure:

An NVIDIA DGX H100 System has several firmware updatable components. Some of the components are on the following two trays in the system:
