# DGX-2 System Firmware Update Container

Release Notes

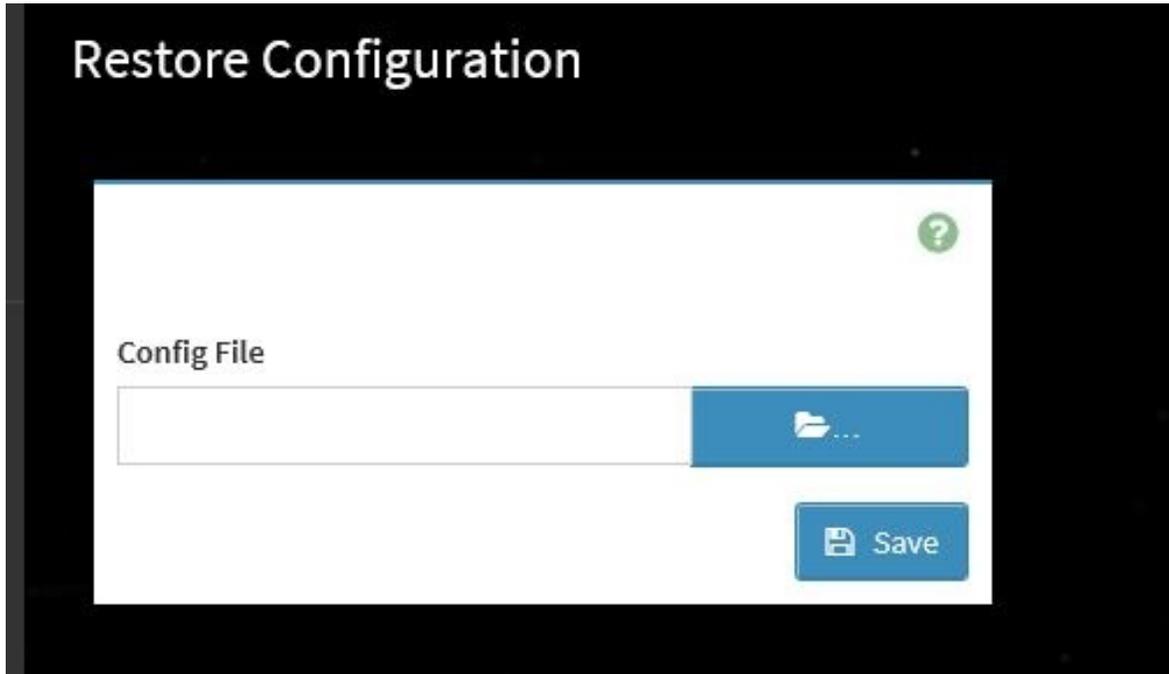
6. As the administrator, log in to the BMC dashboard, then navigate to Maintenance->Restore Configuration.

7. Locate and select the `conf.bak` file downloaded in step 1 and then click Save.
8. Now you can update the PSU firmware.

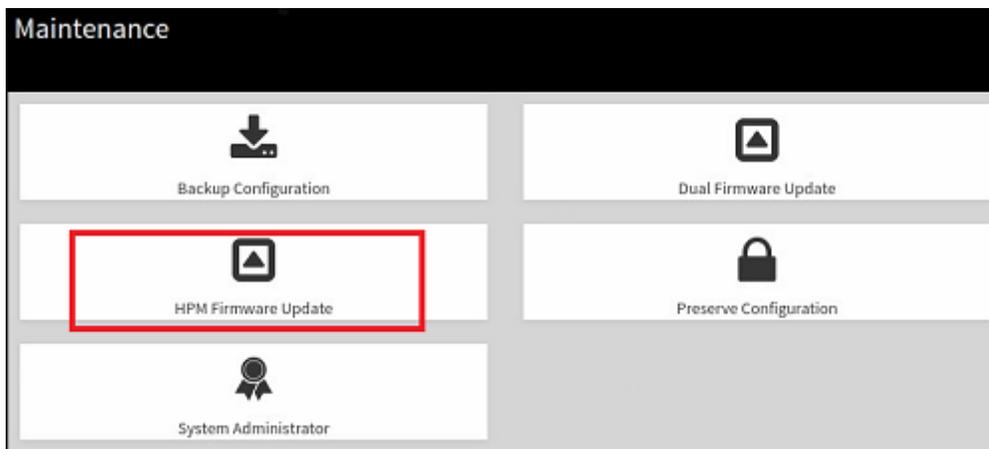
1. Obtain the SBIOS `.hpm` file from the NVIDIA Enterprise Support announcement and copy it your local machine.
2. Remove the DGX-2 from production to ensure against corrupting the BMC.
3. Log in to the BMC dashboard from your local machine and select Maintenance from the left-side navigation pane.
4. Select the HPM Firmware Update card from the list.

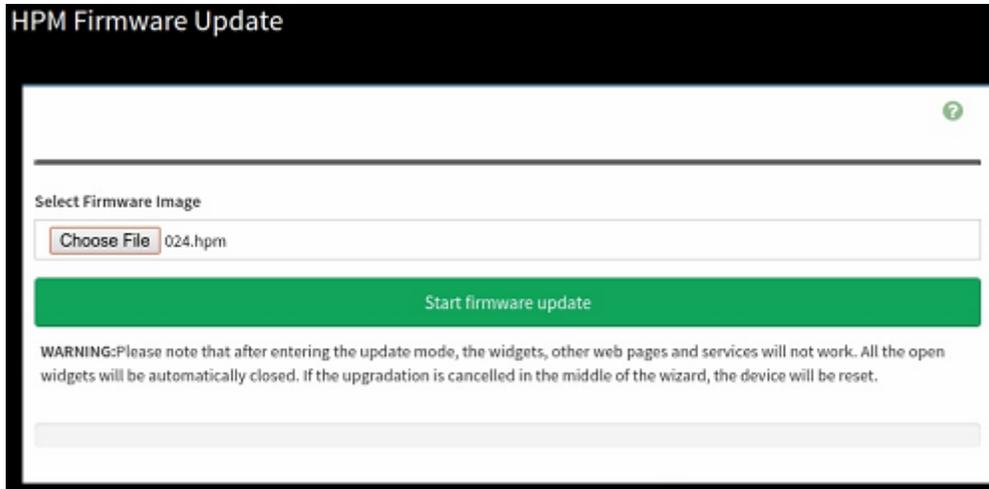
5. Click Choose File, and then locate and select the `.hpm` file corresponding to the update version.

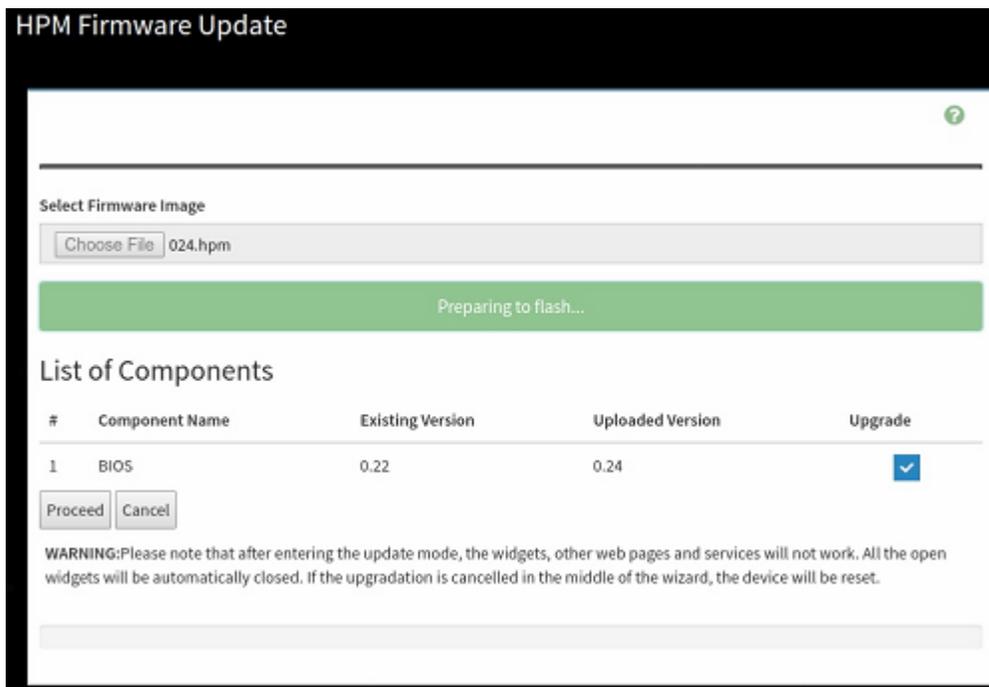
6. Click Start firmware update.
7. Under List of Components, confirm that the Uploaded Version is the intended version, then click Proceed.

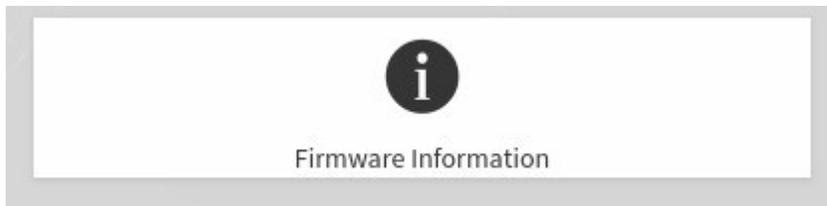
- b). After the shutdown, remove all AC cables from the DGX-2 and wait for ten minutes.
  - c). Re-connect the AC cables, then push the power button to power on the DGX-2. The system reboots to the now updated secondary SBIOS (assuming it originally booted from the primary SBIOS).
10. Log back in to the BMC dashboard and repeat the steps to update the primary SBIOS (assuming it originally booted from the primary SBIOS).
  11. To verify the state of each SBIOS, log in to the BMC dashboard, select Maintenance, then select Firmware Information and view the information under the BIOS section.
