DGX-2 System Firmware Update Container

Release Notes

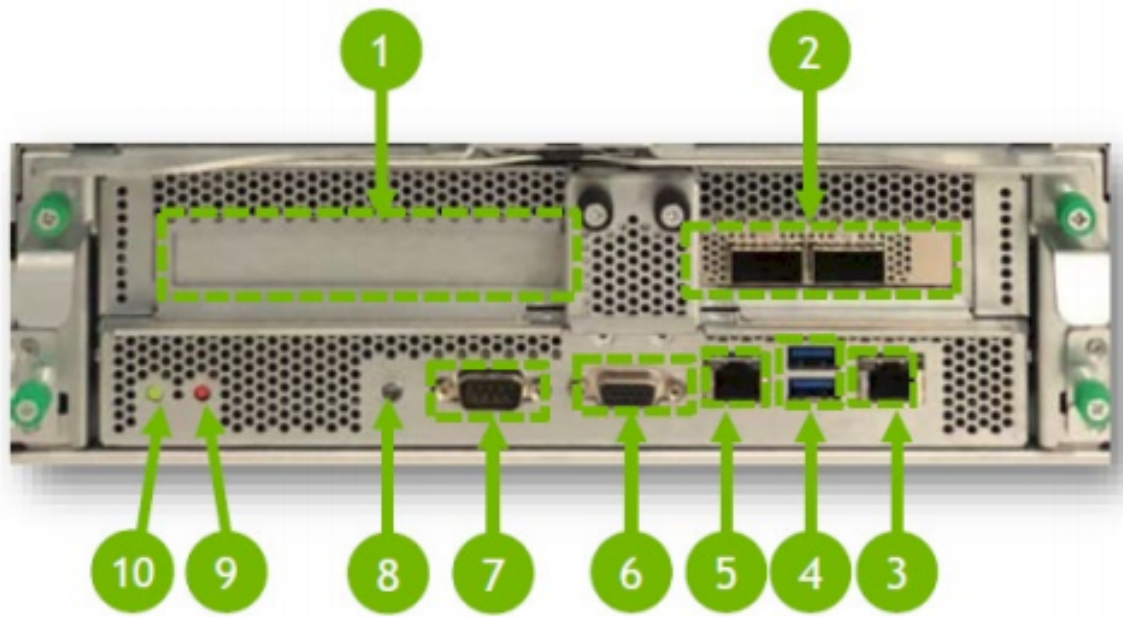
Refer to item 9 in the following image of the back of the DGX-2 system for the location of the BMC reset button.

- ▶ If you have physical access to the system, press the BMC reset button.

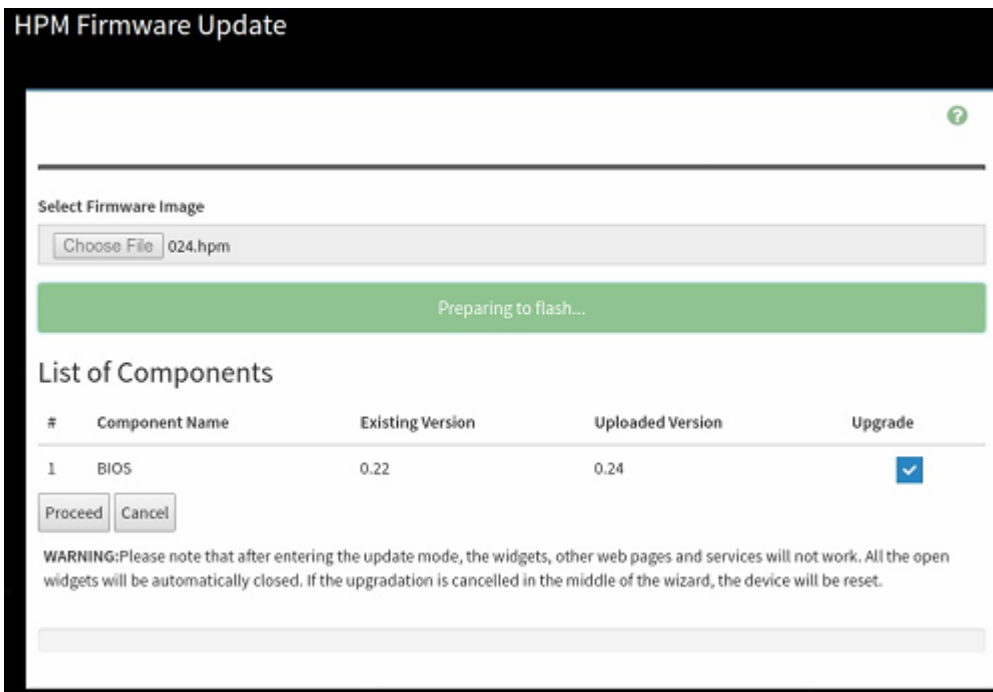
6. Click **Start firmware update**.
7. Under **List of Components**, confirm that the **Uploaded Version** is the intended version, then click **Proceed**.

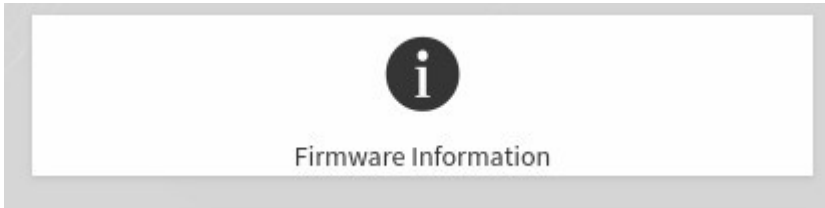
- c). Re-connect the AC cables, then push the power button to power on the DGX-2.
The system reboots to the now updated secondary SBIOS (assuming it originally booted from the primary SBIOS).
10. Log back in to the BMC dashboard and repeat the steps to update the primary SBIOS (assuming it originally booted from the primary SBIOS).
 11. To verify the state of each SBIOS, log in to the BMC dashboard, select **Maintenance**, then select **Firmware Information** and view the information under the BIOS section.
