NVIDIA Jetson Linux

Release Notes

Version 38.4.0 GA

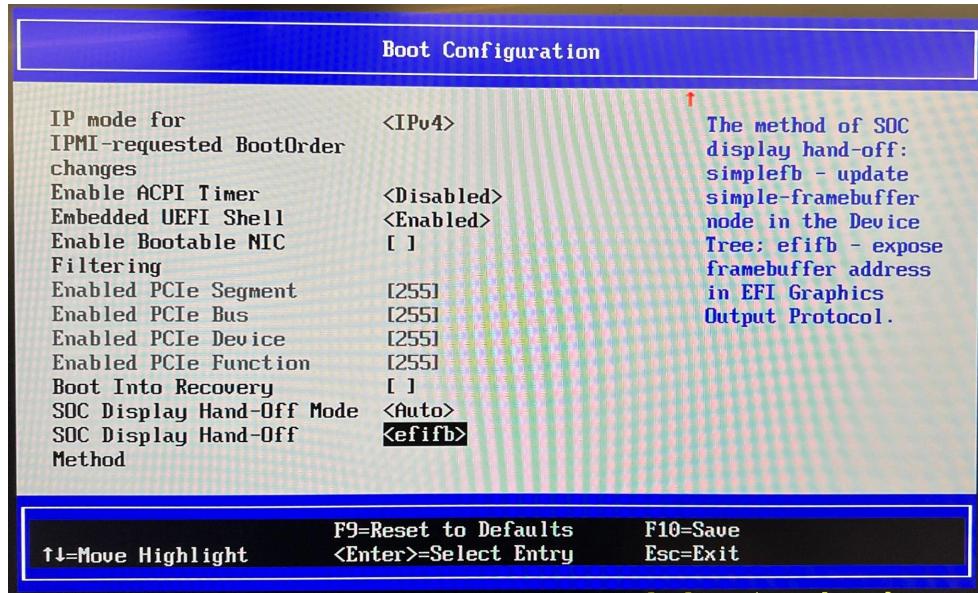
1. Press ESC to enter the UEFI menu.
2. Navigate to **Device Manager** > **NVIDIA Configuration** > **Boot Configuration** and make the following changes:
 - SOC Display Hand-Off Mode: **Auto**
 - SOC Display Hand-Off Method: **efifb**
