# **NVIDIA Networking Server-Side Documentation of Flexboot v3.8.201 & UEFI v14.40.10**

# Overview

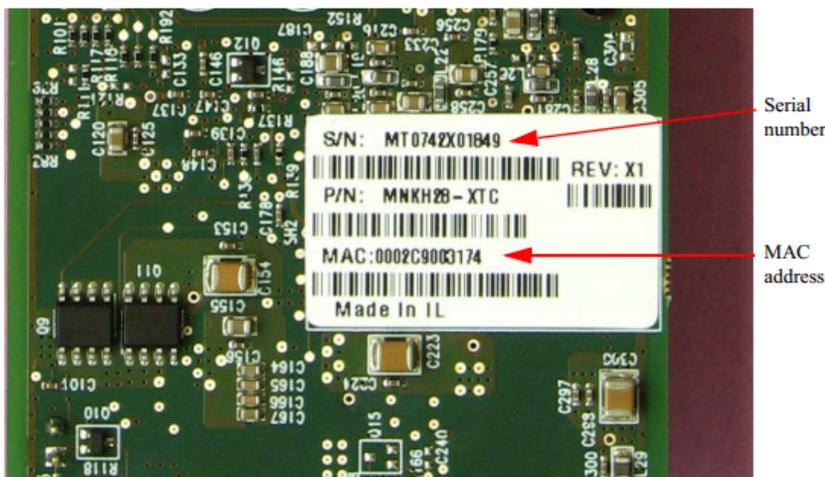
### Extracting the MAC Address – Method I

All Ethernet NICs have a label on the printed side of the adapter card that has the card serial number and the card MAC address.
