NVIDIA Networking Server-Side Documentation of Flexboot v3.9.101 & UEFI v14.41.14 (February 2026 GA Release)

Overview

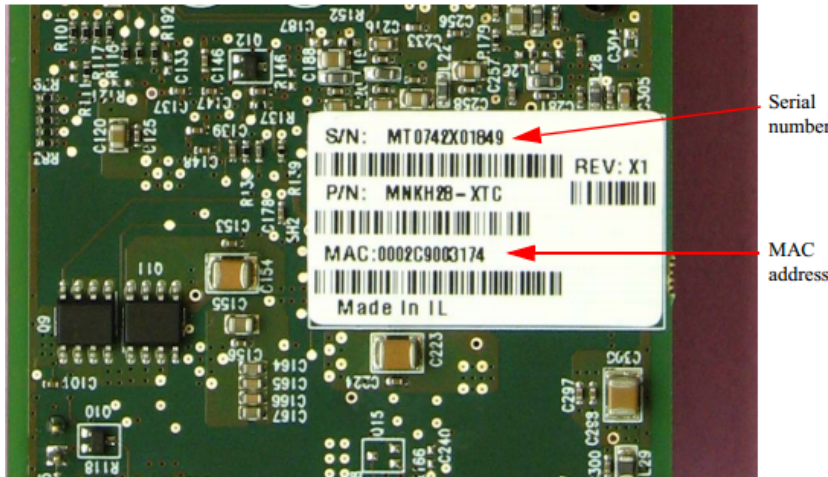
Extracting the MAC Address – Method I

All Ethernet NICs have a label on the printed side of the adapter card that has the card serial number and the card MAC address.
